REPAIR DETAIL FOR TOP FLANGE NOTCH 4'-0" OR LESS FROM BEARING

P3 BY EACOM
 TYPICAL REPAIR DETAILS

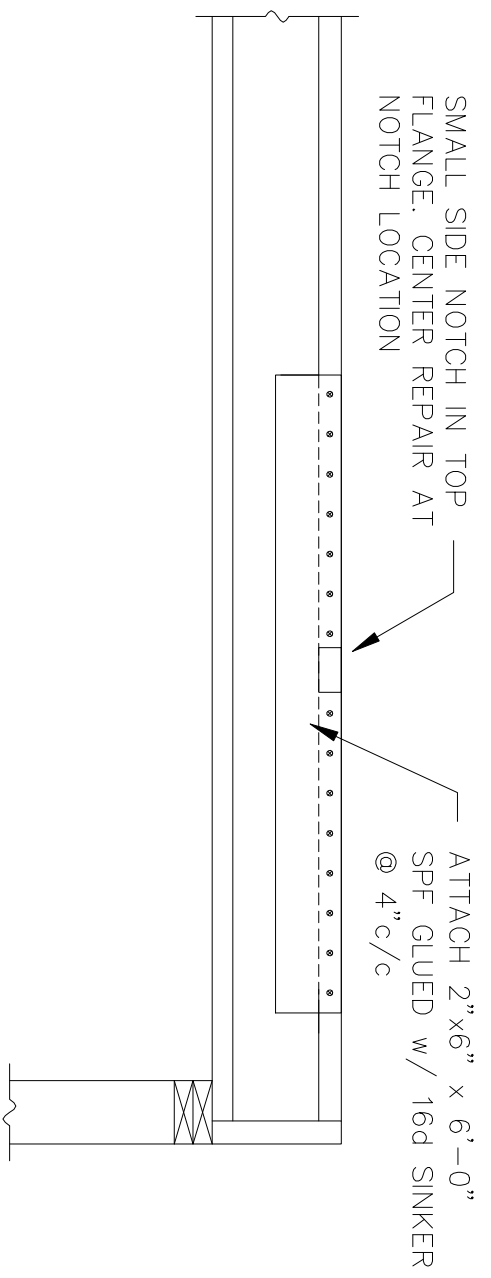
ALL GLUED AND NAILED

NOTE:
 DAMAGE TO I-JOIST FLANGE AND/OR WEB CAN CAUSE FAILURE OF FLOOR SYSTEM. SPAN, SPACING AND LOADING AS WELL AS EXTENT AND LOCATION OF DAMAGE ALL AFFECT THE REPAIR REQUIRED.
 EACH CASE SHALL BE REVIEWED.
